Manhole Inspection Summary

Manhole # S35II_048MH

Insp Date: **3/13/07 8:50 AM**

Location Address: **1600 GUILFORD AVE**

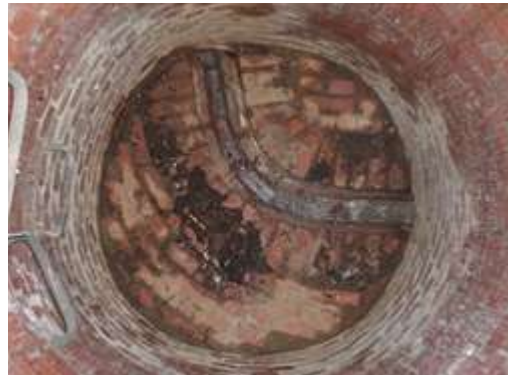
Top View

Barrel infiltration. Bench and Channel debris.

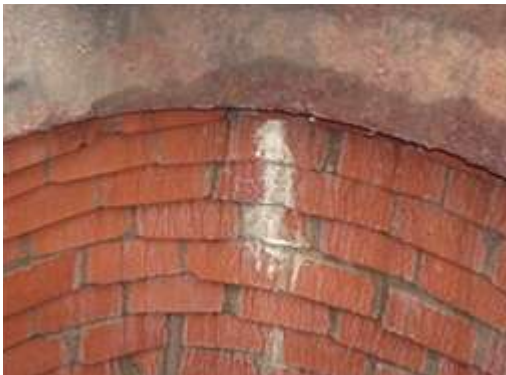
Defect

Frame leaks. Corbel infiltration.

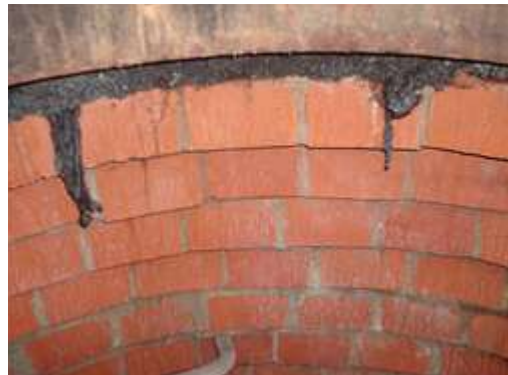
Defect

Frame leaks. Corbel infiltration.

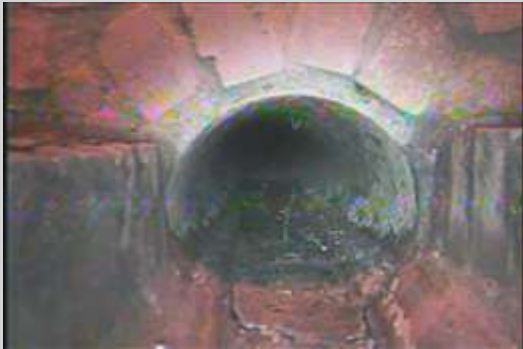
8 in. Circular Gravity Sewer Pipe Out @ 12 O'Clock

Deposits: ☐ None ☒ **Mud** ☐ Sludge ☒ **Debris** ☐ Grease

Silt Depth: **0.5** (in.) Deposits Extent: **Light**

Infiltration: **None** Pipe Seal Cond: **Unknown**

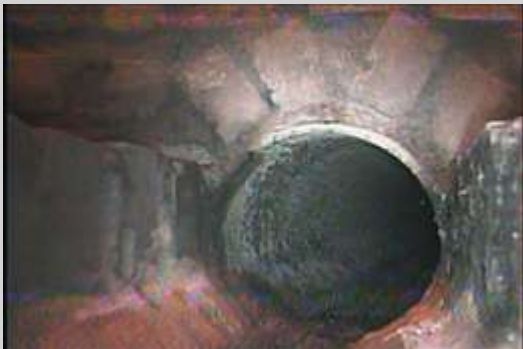
8 in. Circular Gravity Sewer Pipe In @ 3 O'Clock

Deposits: ☐ None ☒ **Mud** ☐ Sludge ☒ **Debris** ☐ Grease

Silt Depth: **0.5** (in.) Deposits Extent: **Light**

Infiltration: **Evidence** Pipe Seal Cond: **Unknown**
